Customer-Led Network
Revolution

CLNR Power Quality Assessment

Impacts of Low Carbon Technologies

CLNR-L146

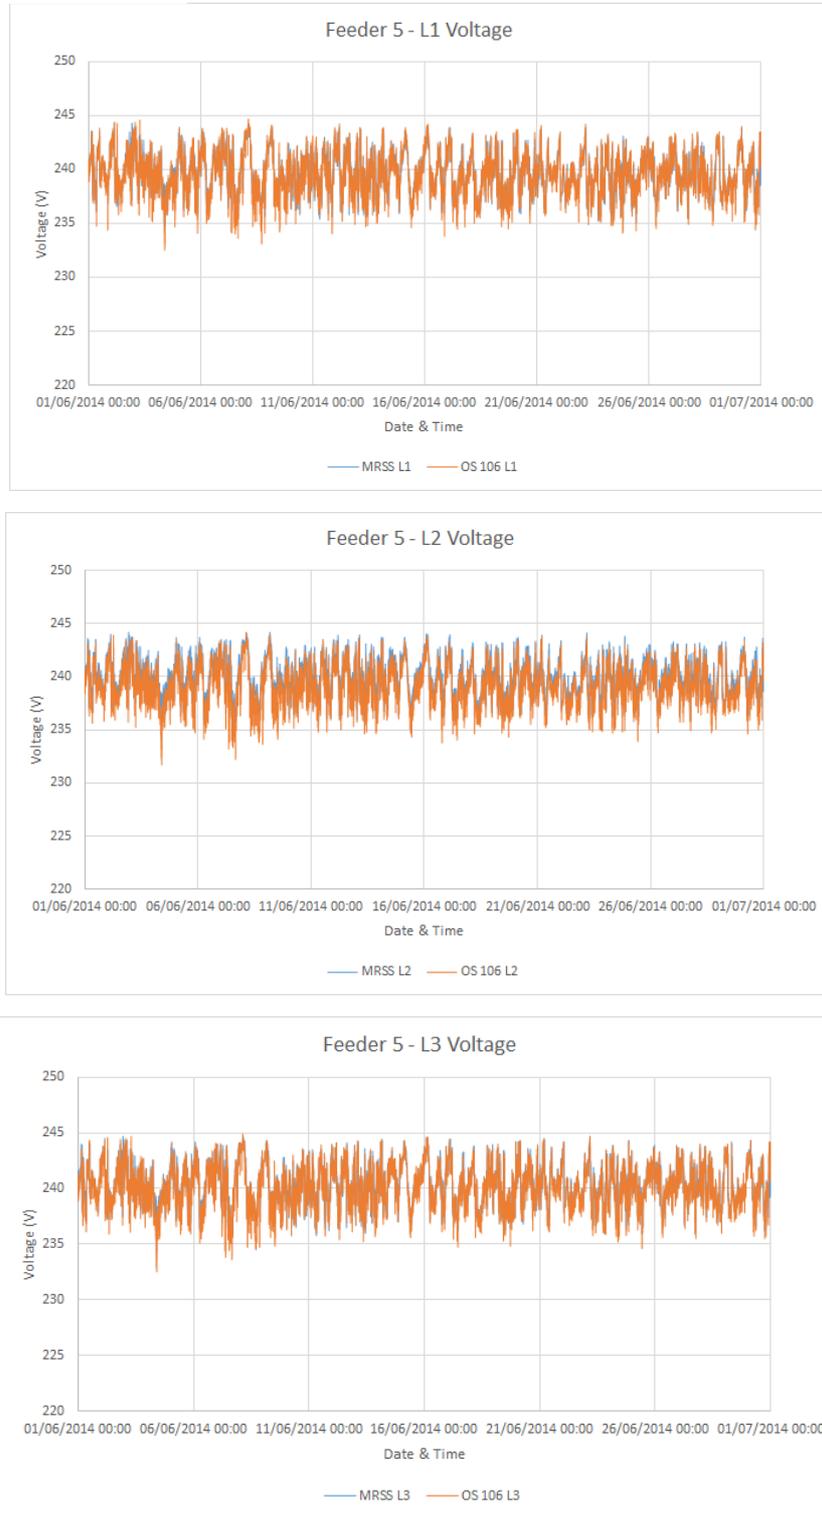
Feeder 5 has no PV installations connected to it, the feeder is relatively short and as a consequence the remote linkbox measurements are electrically close to the Mortimer Road substation.

Figure 51 – Feeder 5 Voltage Profiles

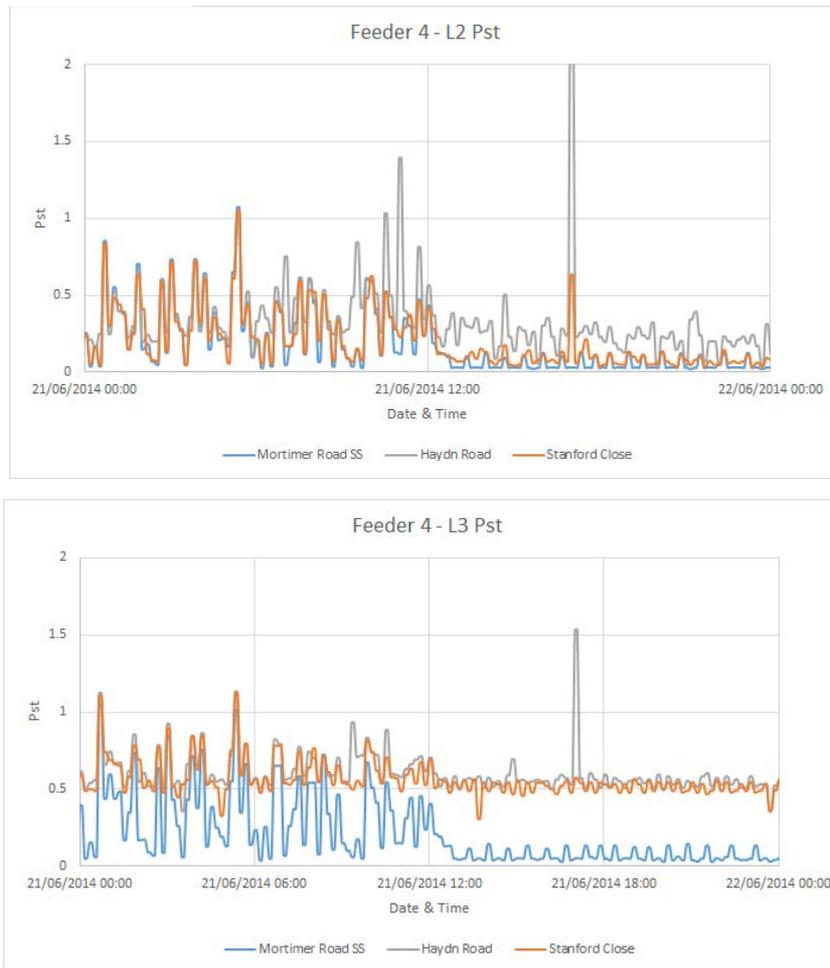
It can be seen that although the values of Pst measured at Haydn Road are potentially of concern they are a fairly localised effect not being reflected at either Stanford close or Mortimer Road measurement points. This suggests that the cause of this disturbance is close to the monitoring point at Haydn Road and whilst giving rise to significant voltage disturbances at that point the fact these are not reflected further back into the network indicates that the magnitude of the load change is relatively small compared to the overall network capacity.

Figure 57 – Feeder 4 Pst 21 June 2014

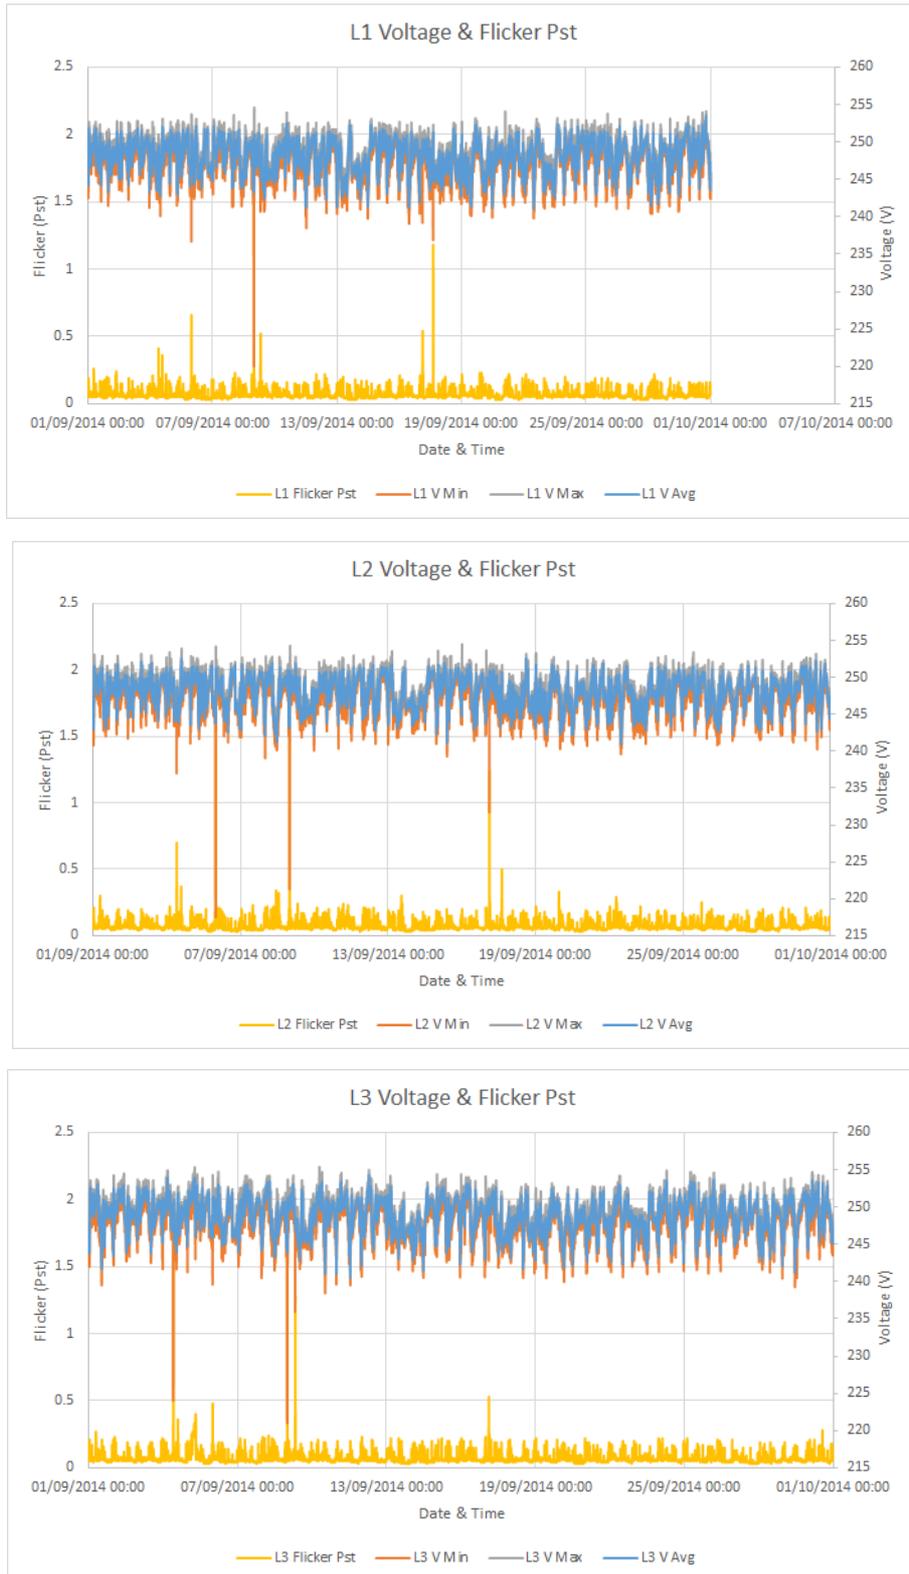
Figure 68 Voltage Variation and Flicker Values for South Shields EV Cluster
